GEOCHEMICAL ASSAY TESTING FOR THE POSSIBLE PRESENCE OF AIRBORNE CARCINOGENS AT THE PROPOSED KIRKLAND HIGH QUALITY POZZOLAN MINE, YAVAPAI COUNTY, ARIZONA

BLM Hassayampa Field Office Locatable Minerals Program, Phoenix, AZ
Dr. S. Cave. Geologist

April 2018 Draft

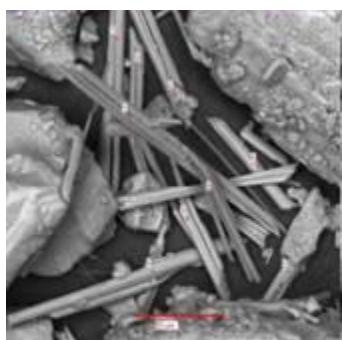
Erionite (500X magnification)

Erionite is a naturally occurring zeolite mineral. It can be found in volcanic ash that has been locally altered by weathering and ground water. Erionite can form spheres or more commonly fibrous masses in the hollows of rock formations. Its color varies from white to clear and can have a green, gray or orange tint (mindat, webmineral).

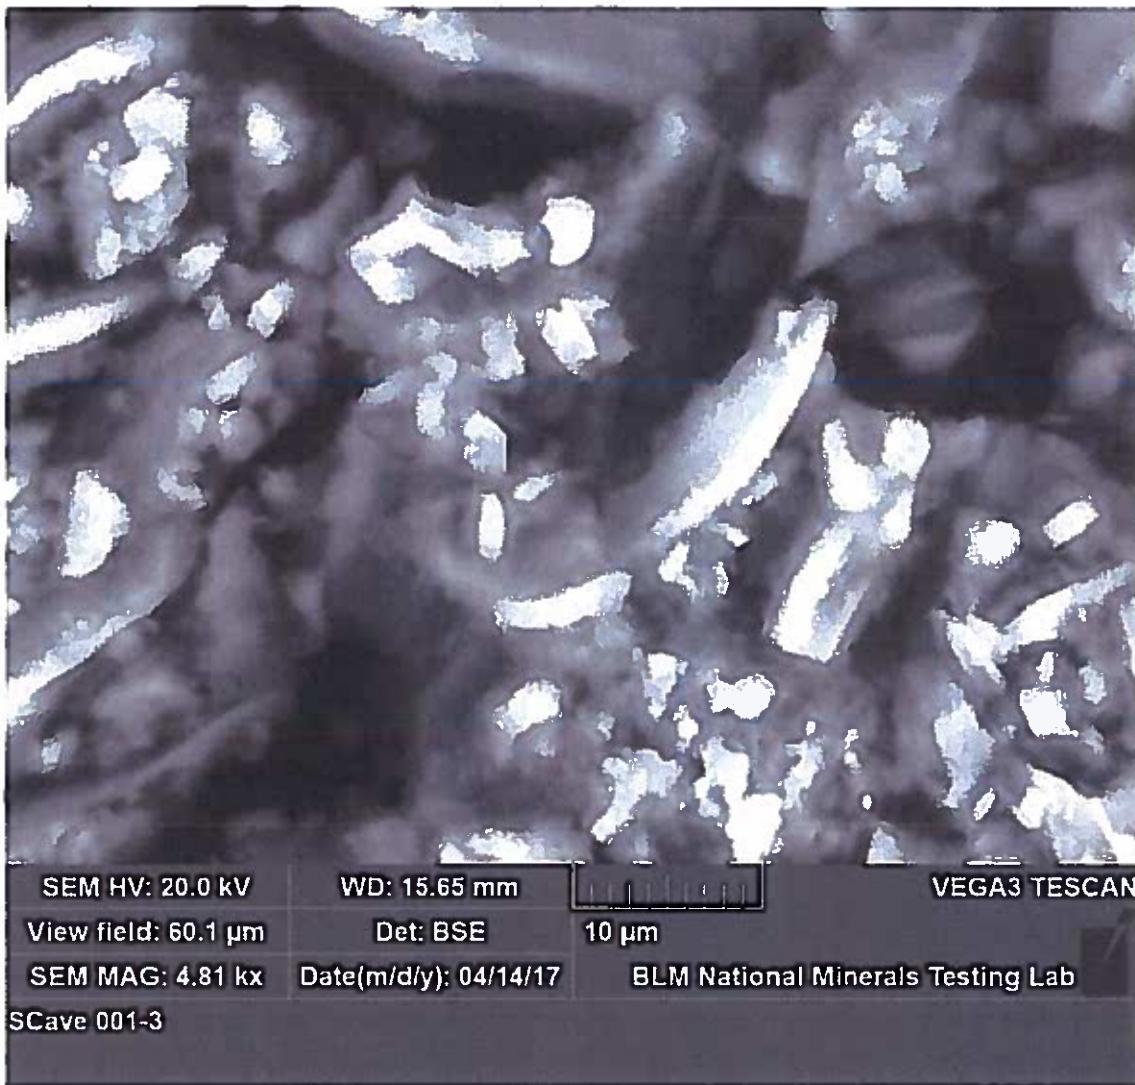
Image SCave 001-3: Magnification 4810X, no Erionite present.

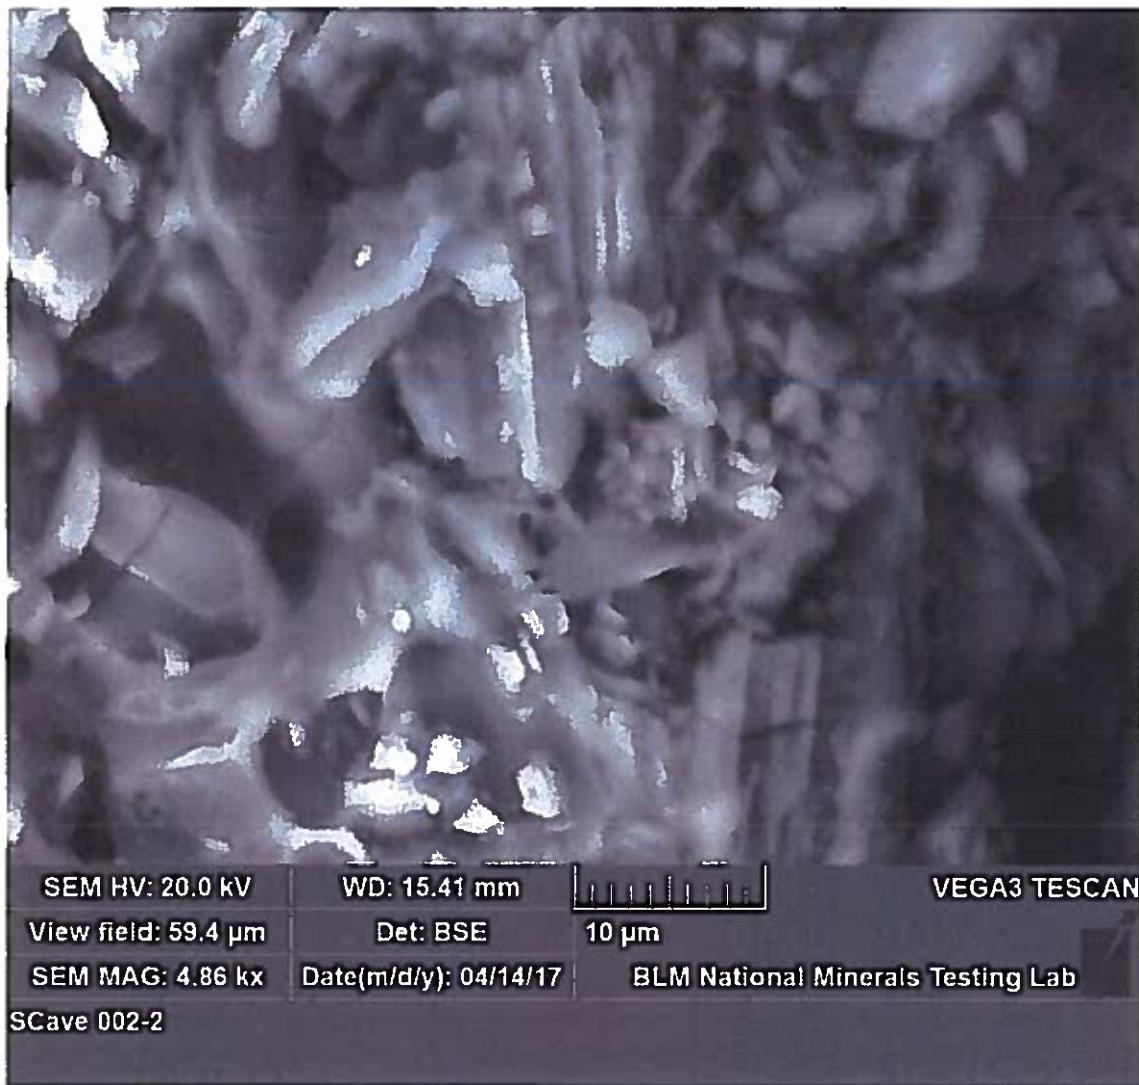
Image SCave 002-2: Magnification 4860X; no Erionite present.

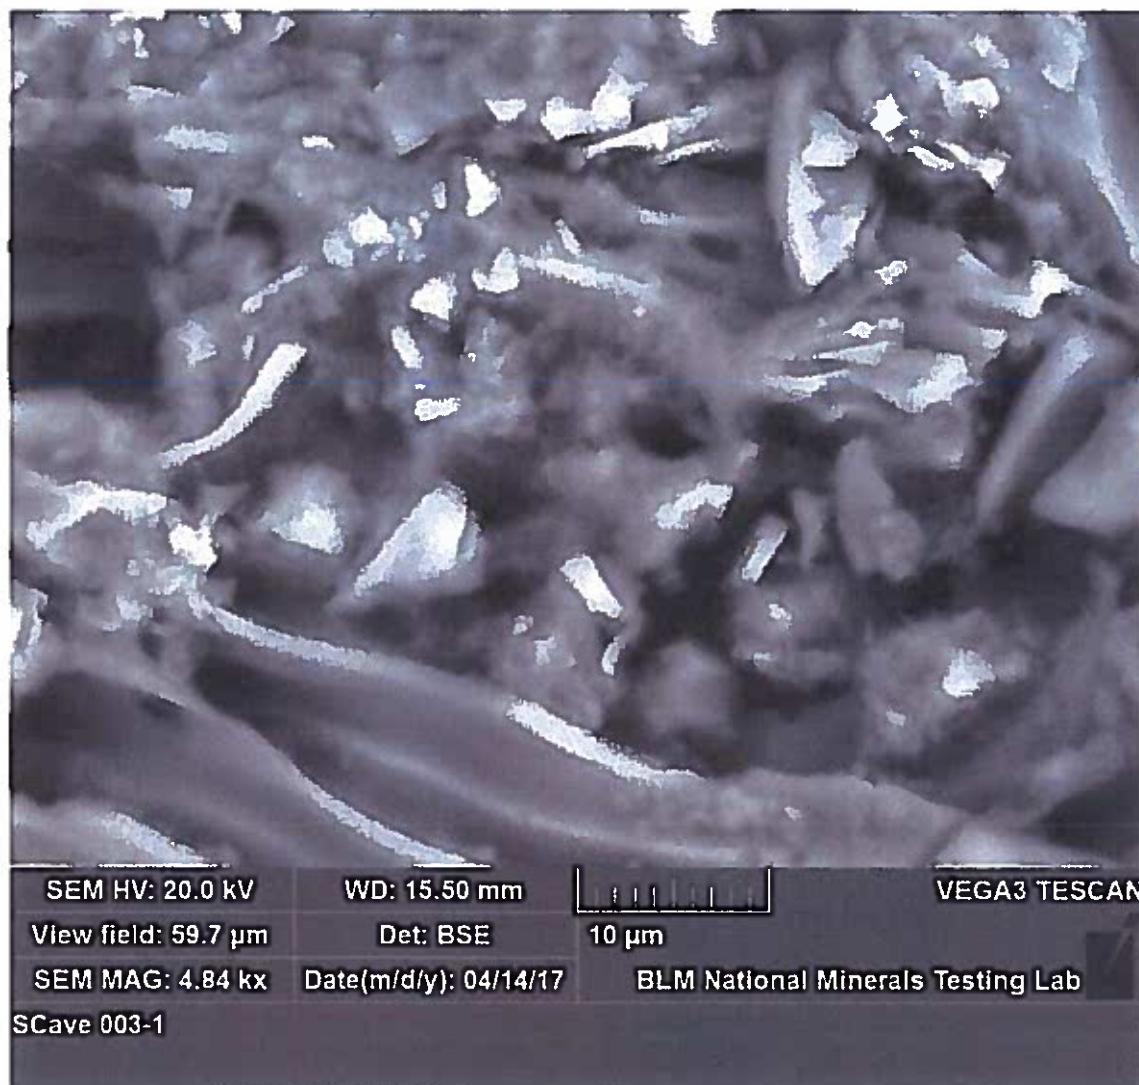
Image SCave 003-1: Magnification 4840X; no Erionite present.

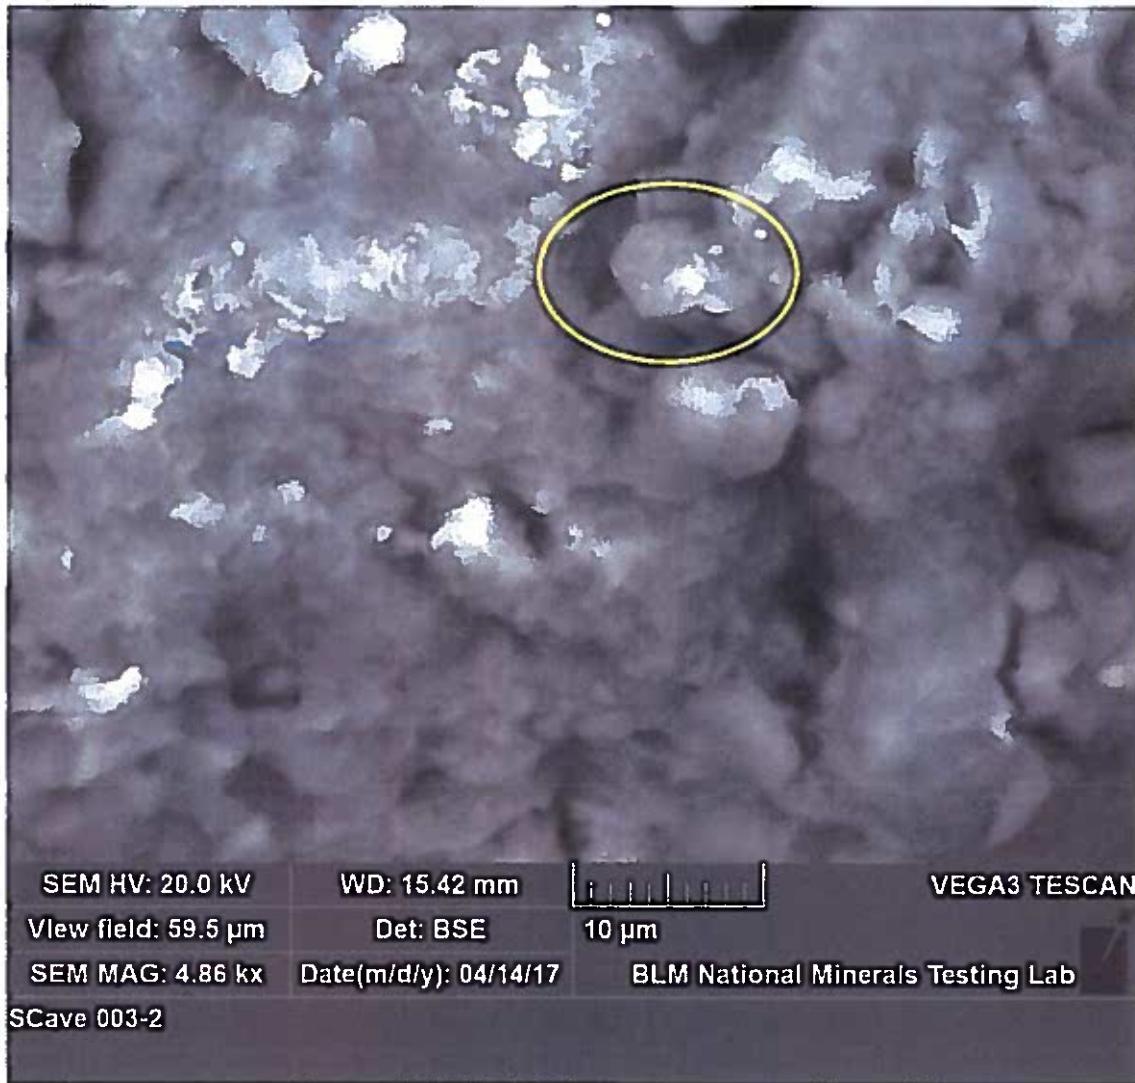
Image SCave 003-2: Magnification 4860X; a different perspective, note the clay particle (circled). No Eryonite present.

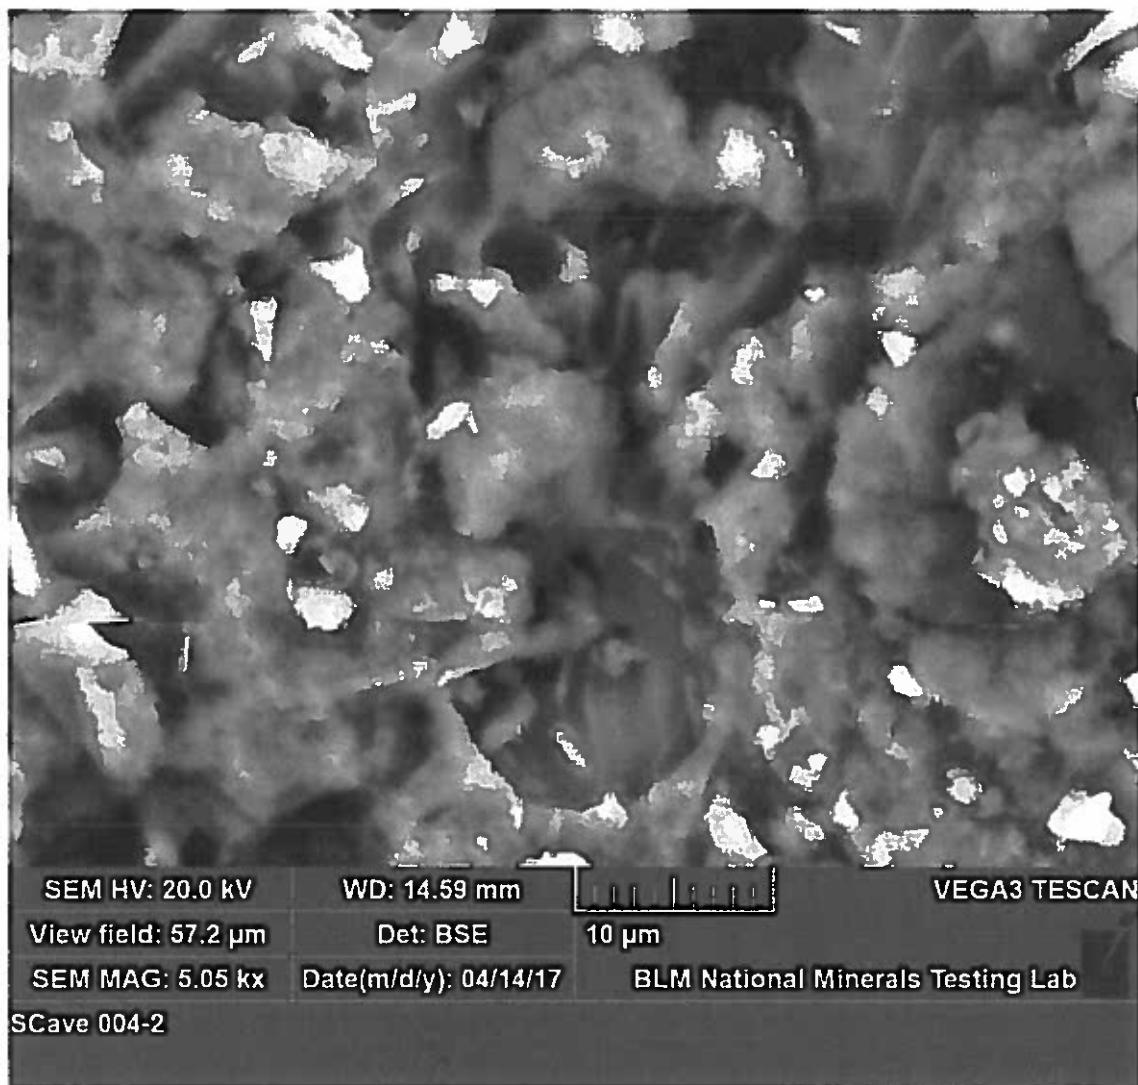
Image SCave 004-2: Magnification 5005X; no Erionite present.

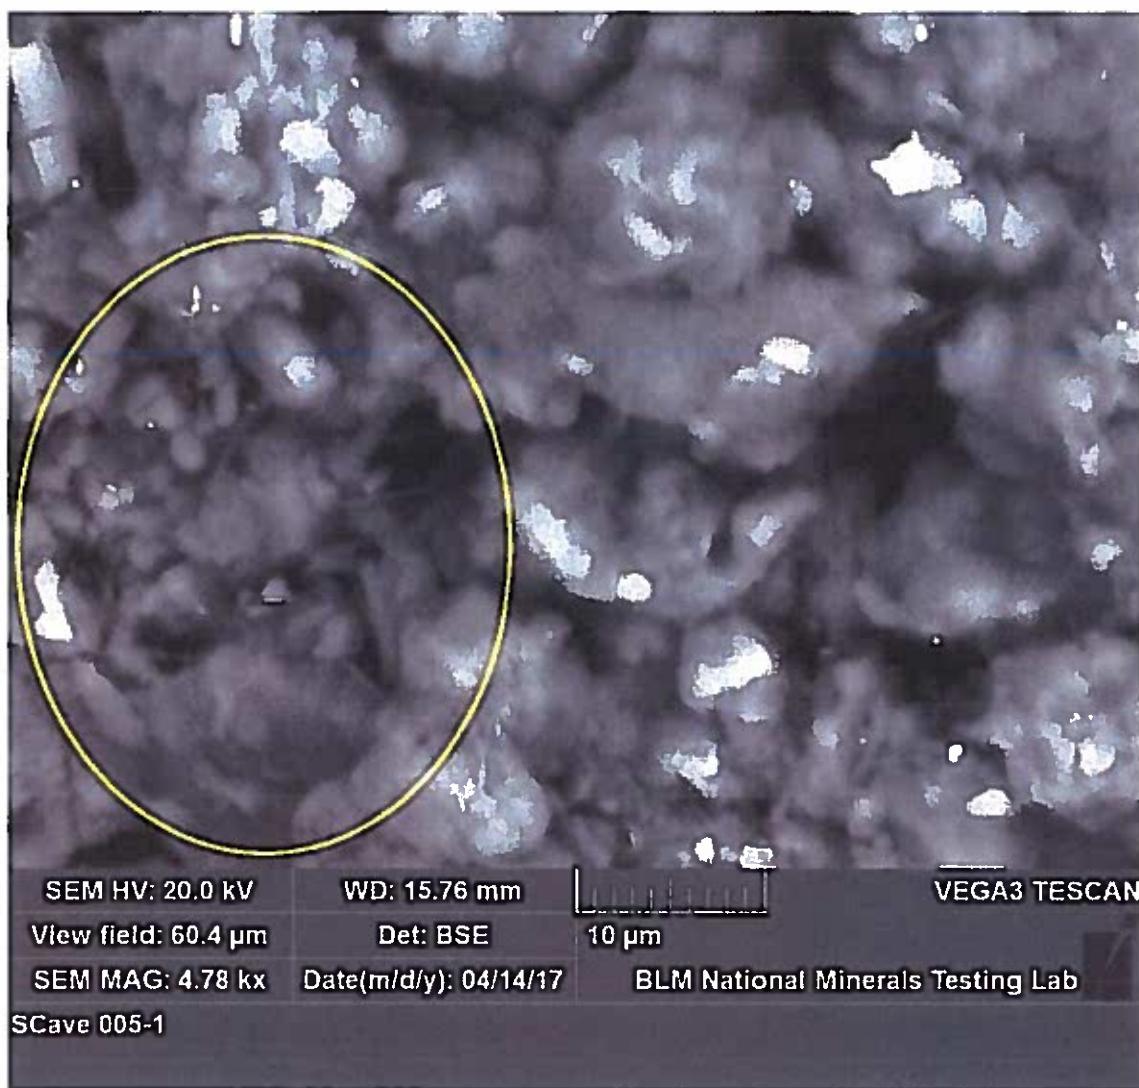
Image SCave 005-1 Magnification 4780X; about 2% Erionite present Note acicular needles (circled)

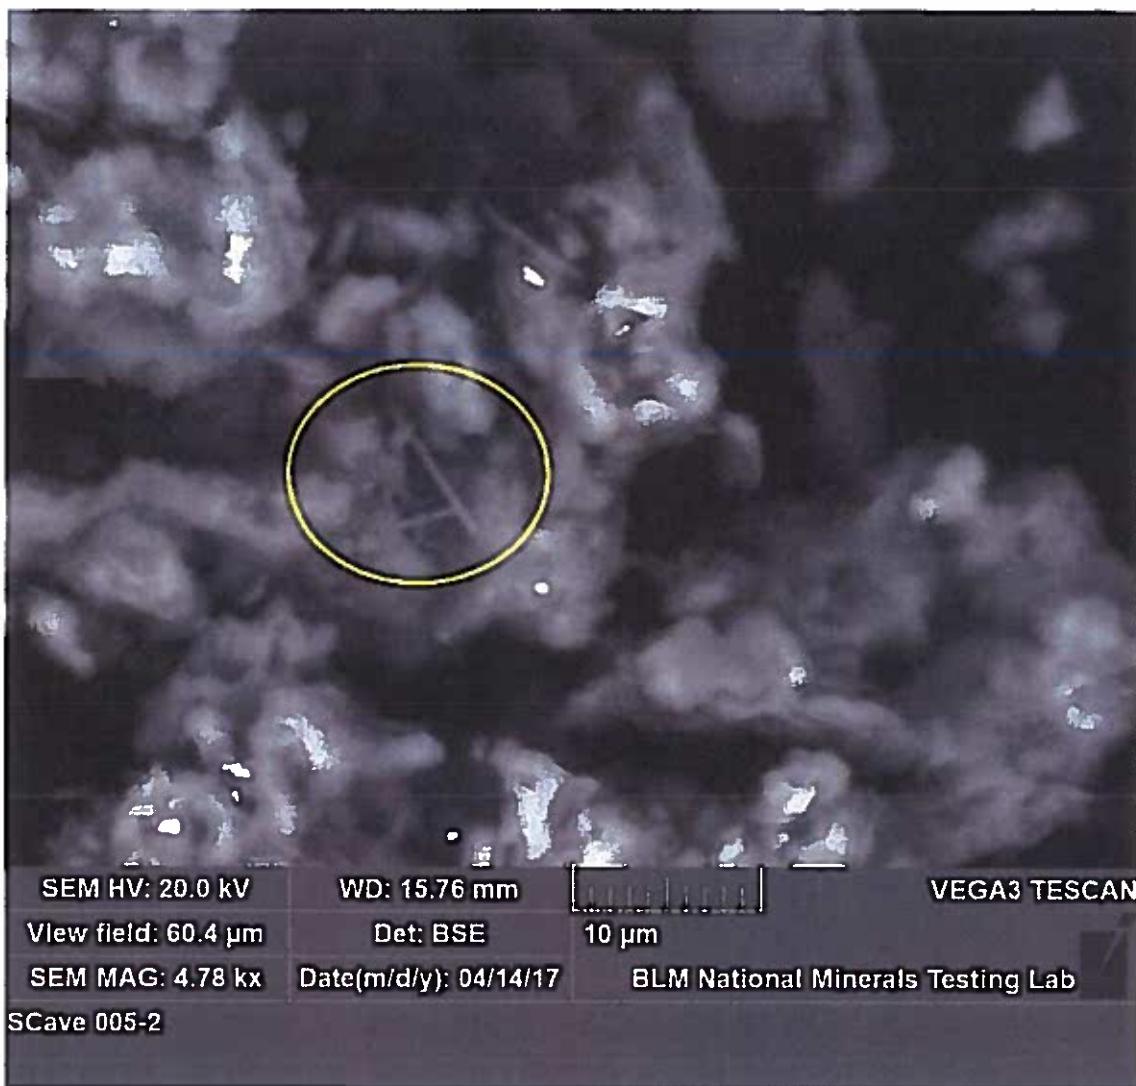
Image SCave 005-2: Magnification 4780X; less than 2% Erionite present. Note acicular needles (circled).

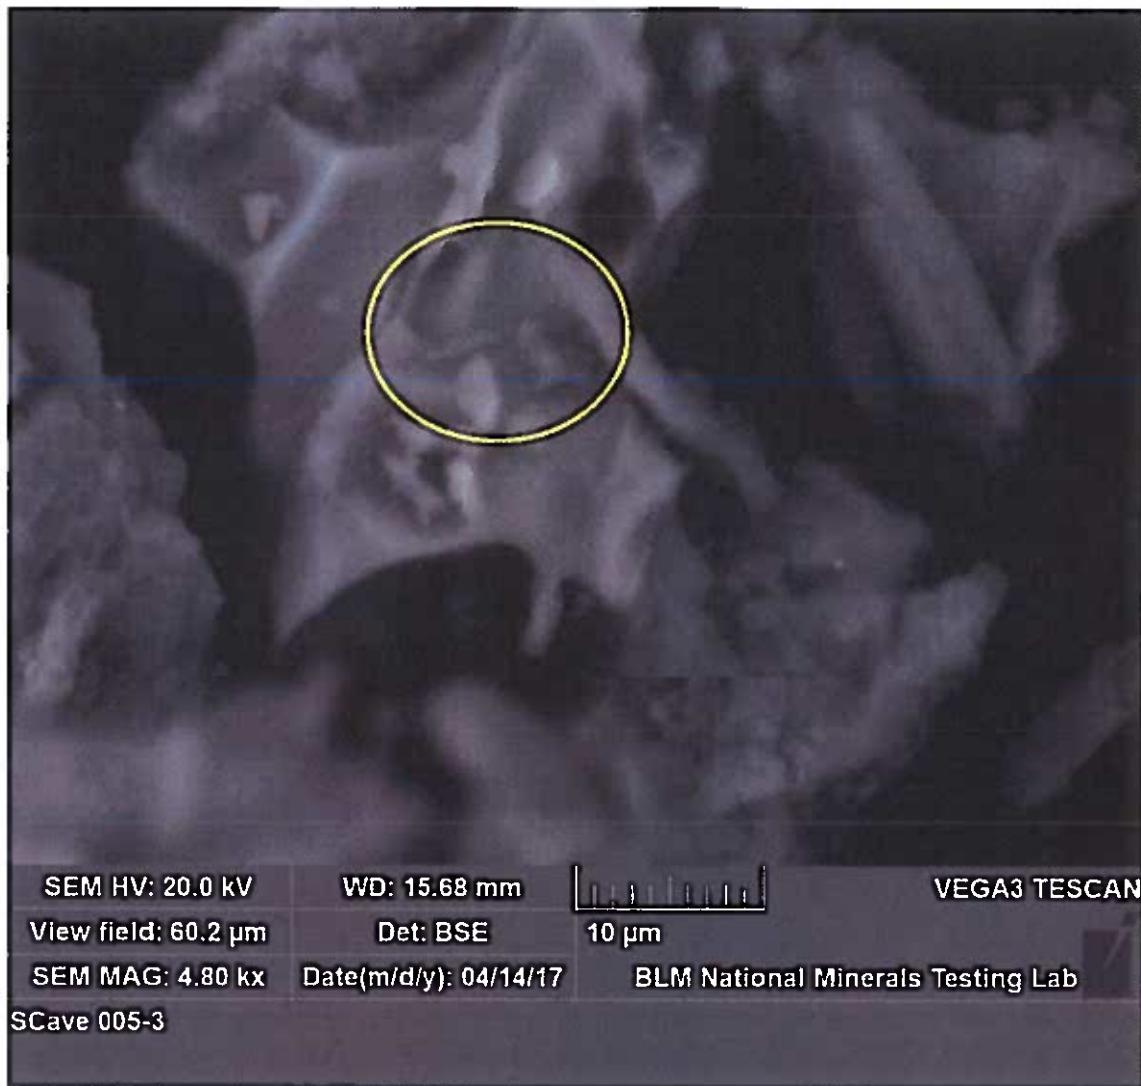
Image SCave 005-3: magnification 4800X; one Erionite acicular crystal present.

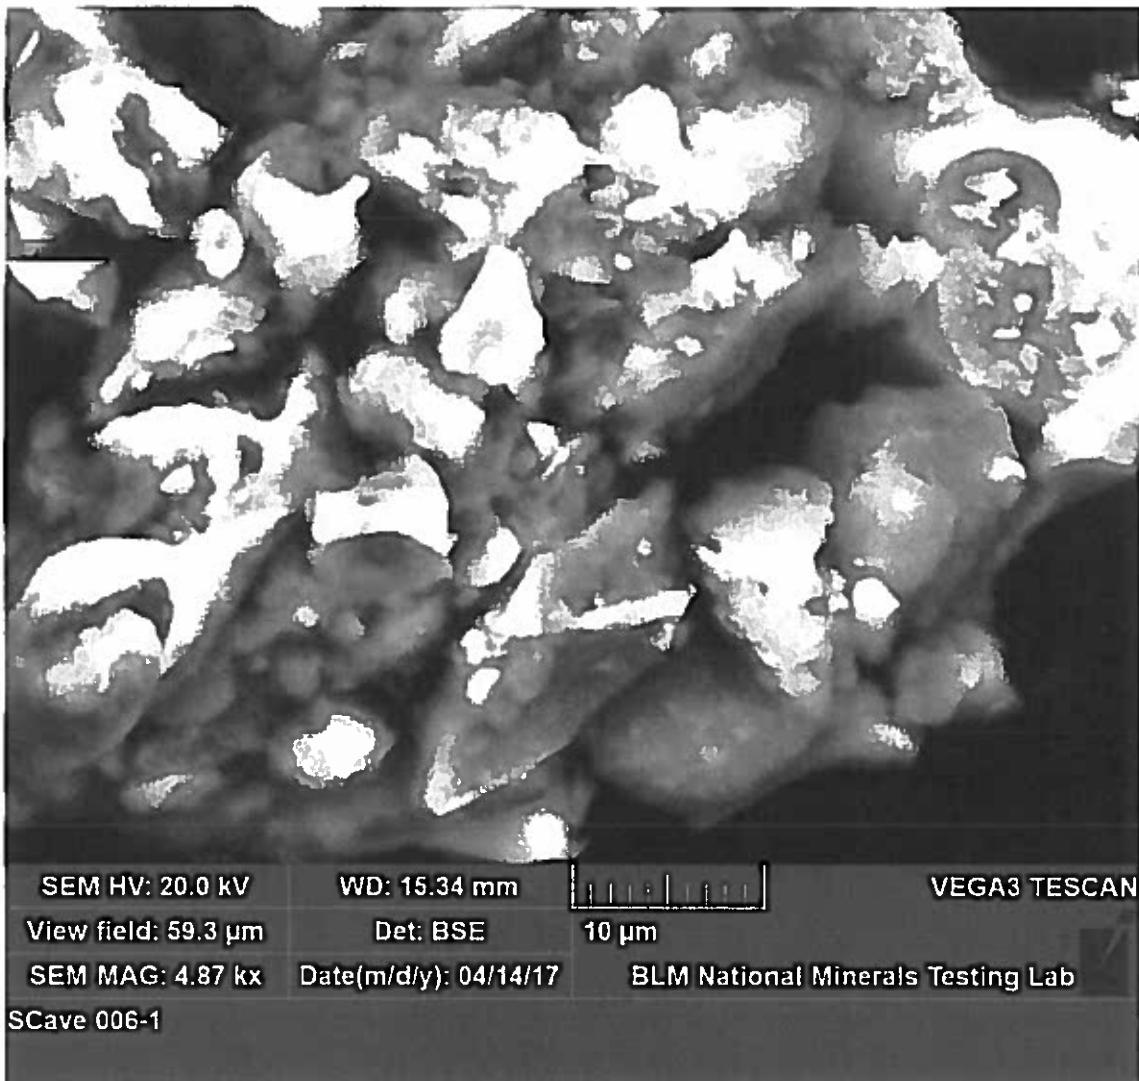
Image Scave 006-1: Magnification 4870X; no Erionite present

SEM HV: 20.0 kV	WD: 15.34 mm		VEGA3 TESCAN
View field: 59.3 μm	Det: BSE	10 μm	
SEM MAG: 4.87 kx	Date(m/d/y): 04/14/17	BLM National Minerals Testing Lab	
SCave 006-1

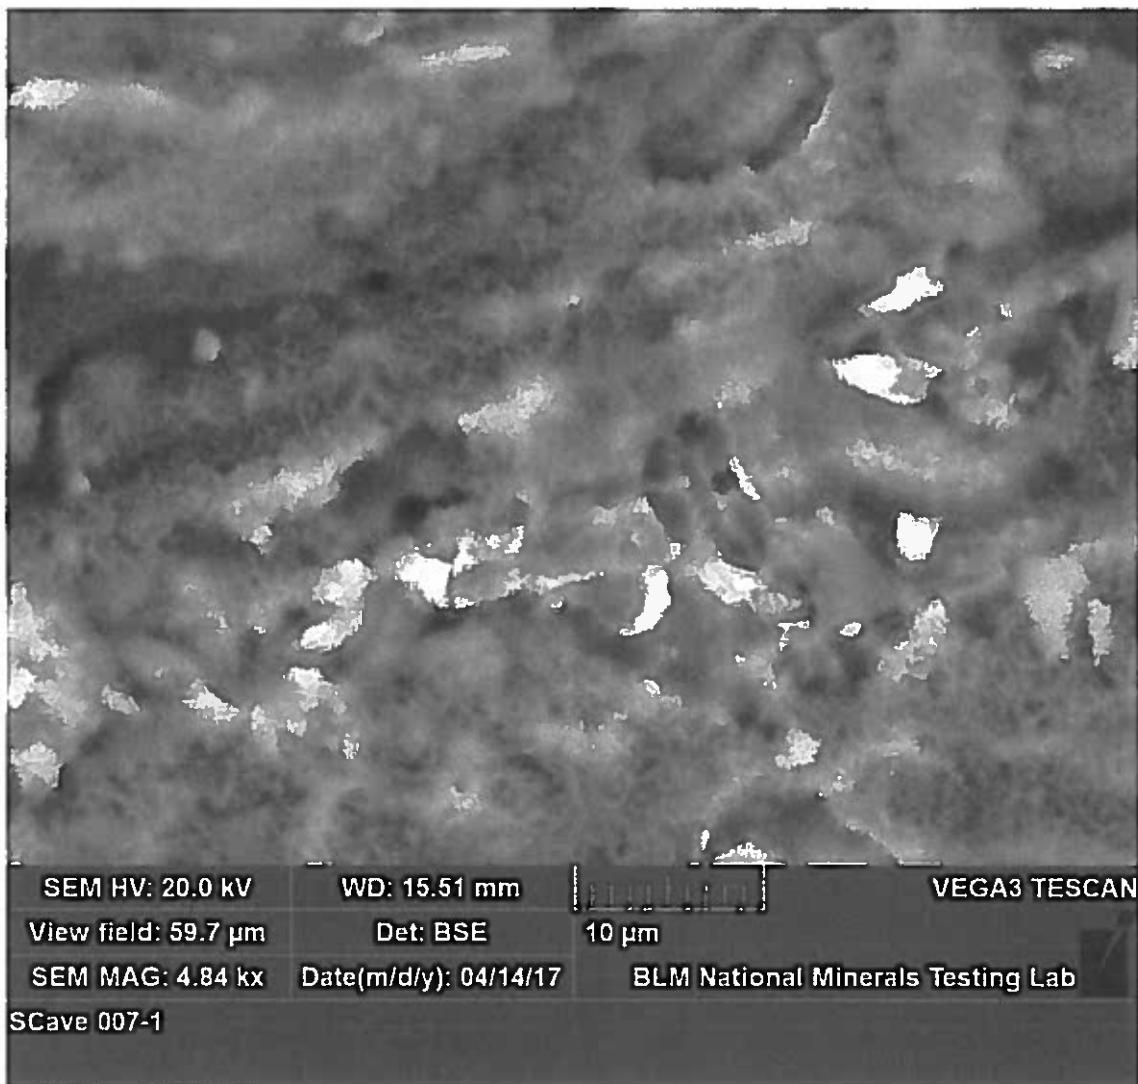
Image SCave 007-1: Magnification 4840X; no Erionite present.

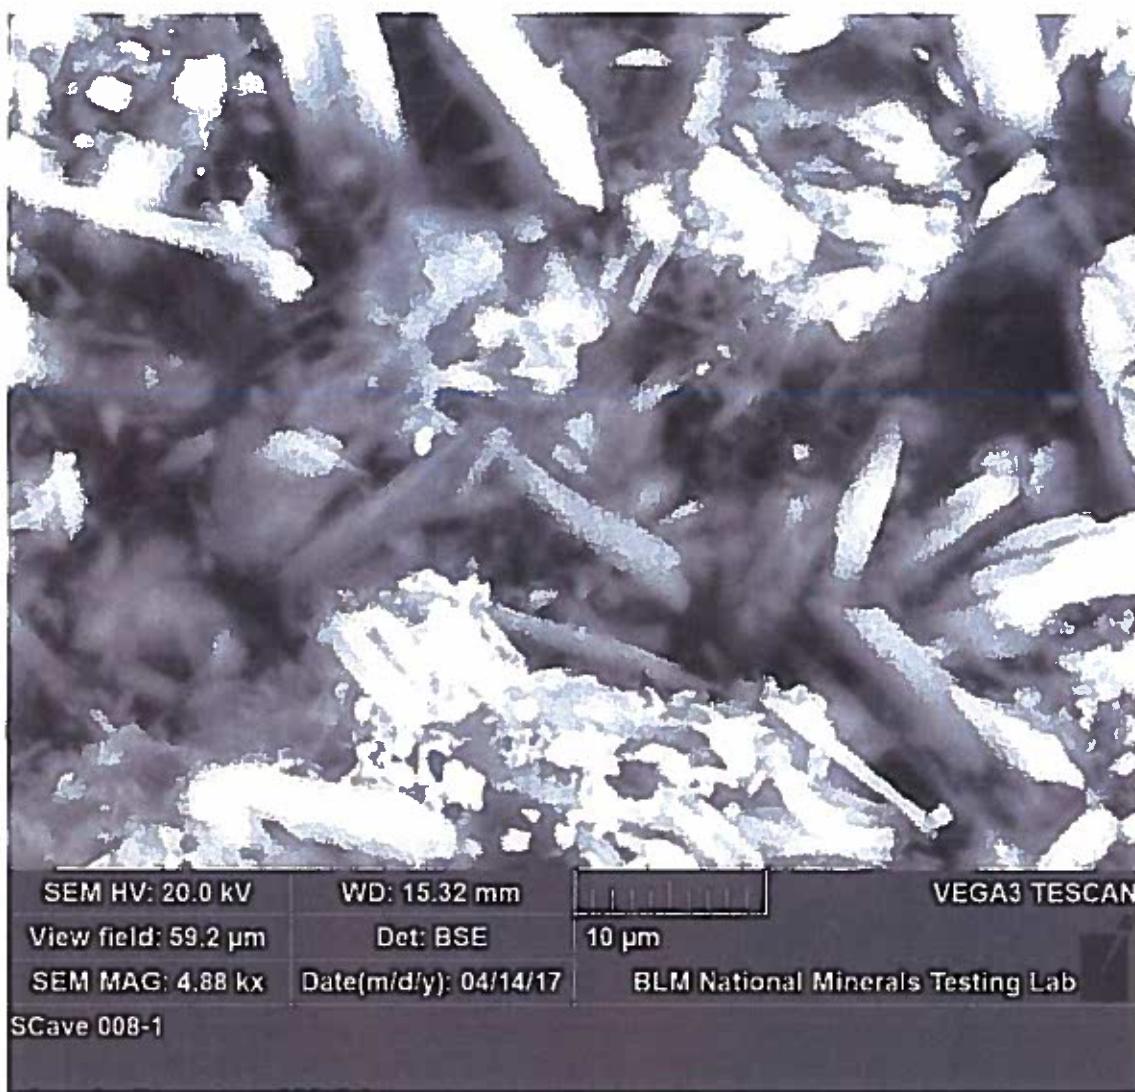
Image SCave 008-1: Magnification 4880X; abundant Erionite present.

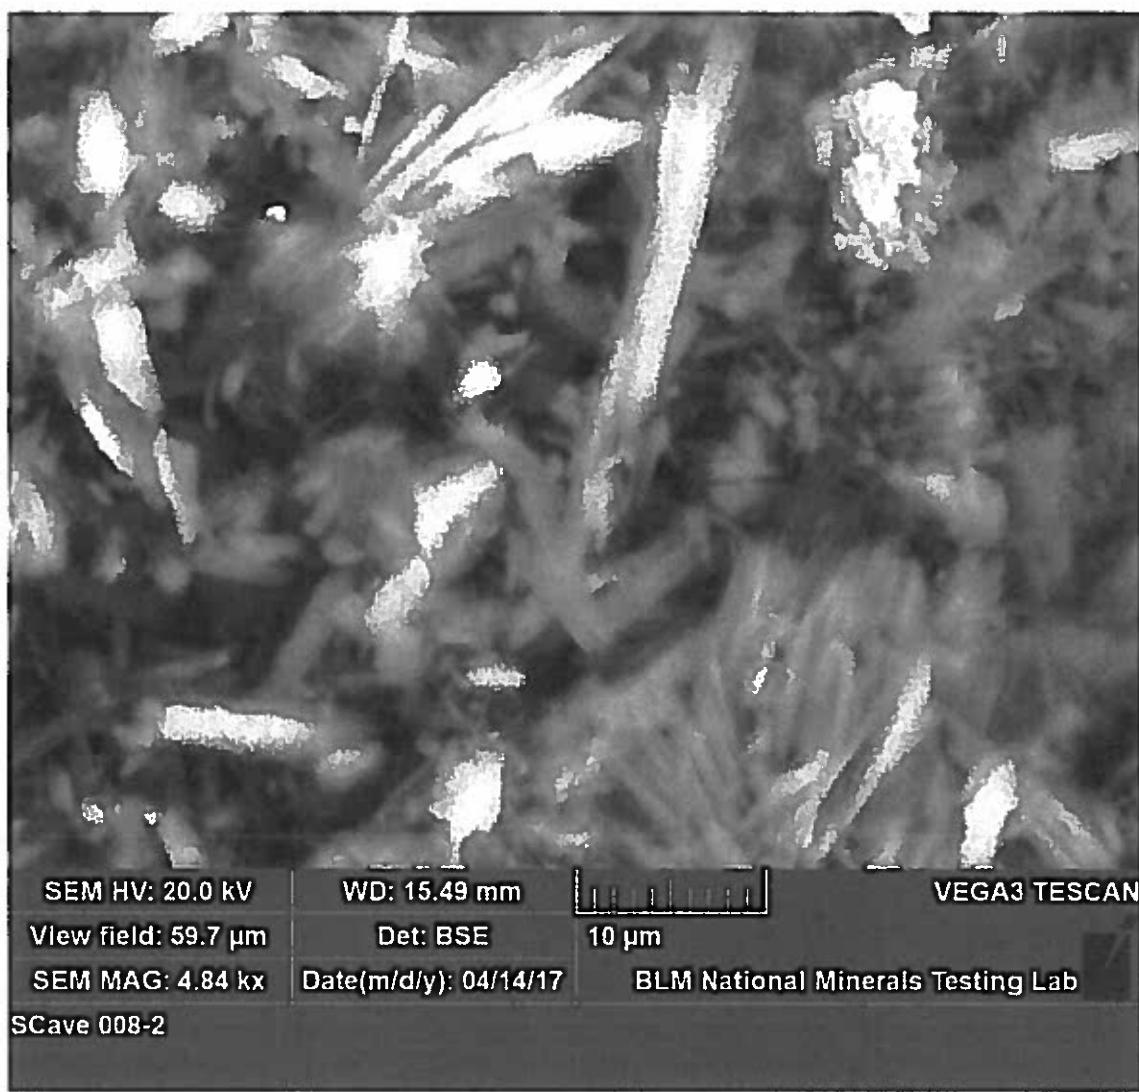
Image SCave 008-2: Magnification 4840X; abundant Erionite present.

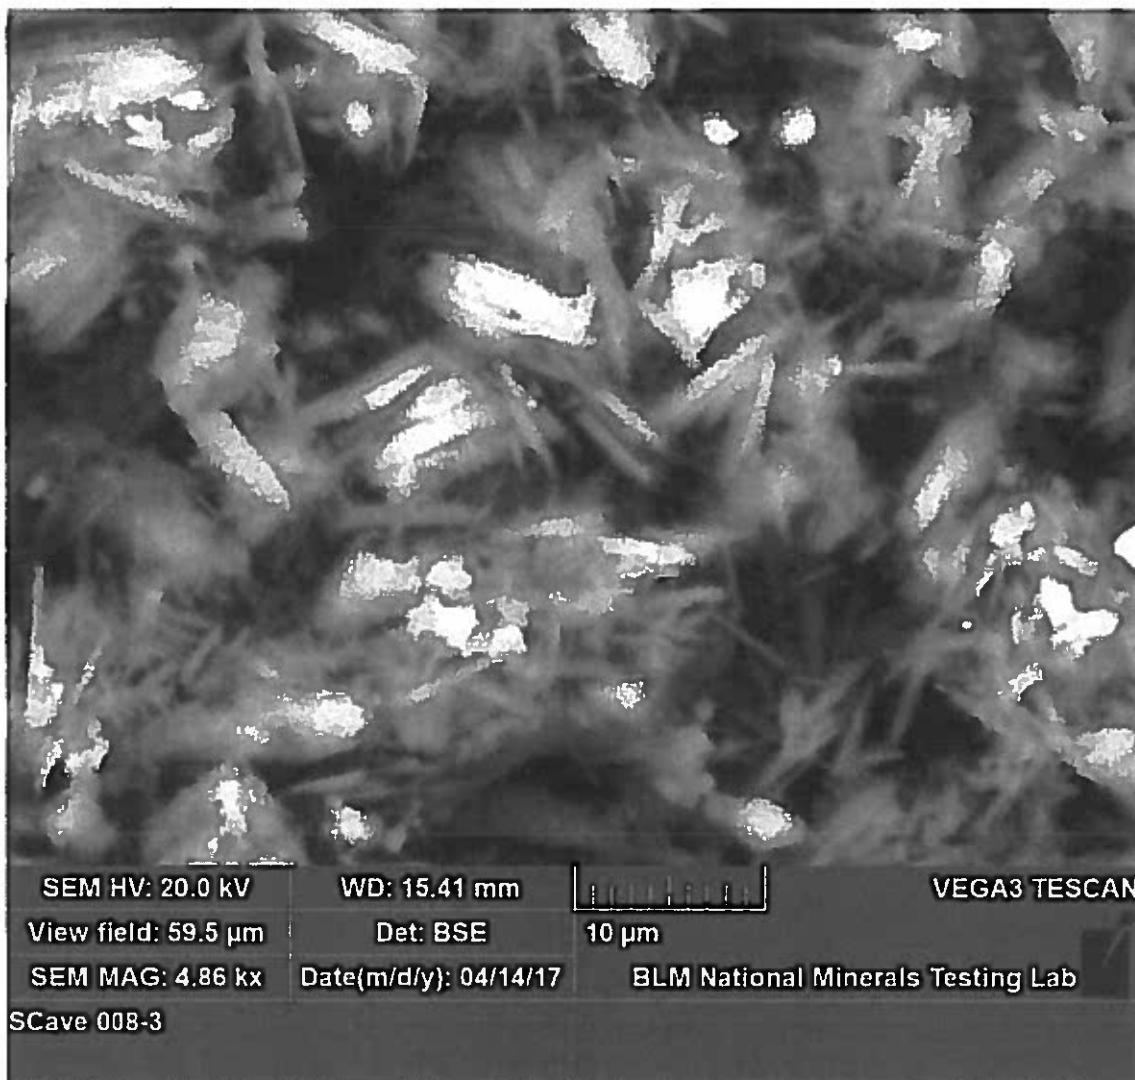
Image SCave 008-3: Magnification 4860X; abundant Erionite present.

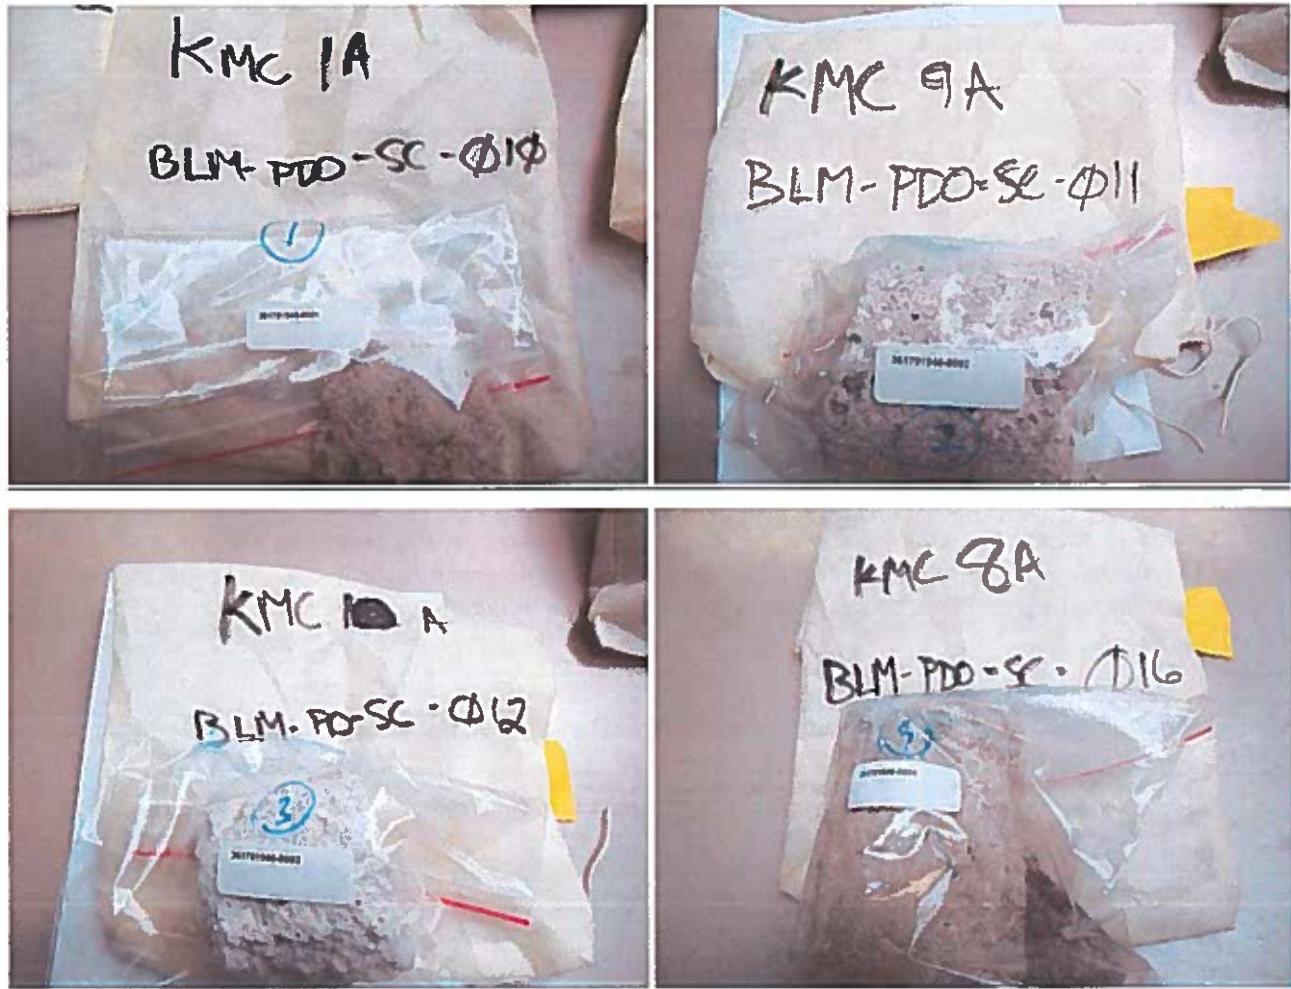
Figure 1: Images of the as-received samples.

The full amount of each of the as-received samples (see Figure 1) was milled to 250 μm nominal size using a puck mill. An aliquot of the material from each sample was sieved using 250 μm screen and packed onto bulk sample holders for analysis. XRD patterns were obtained using the following conditions:

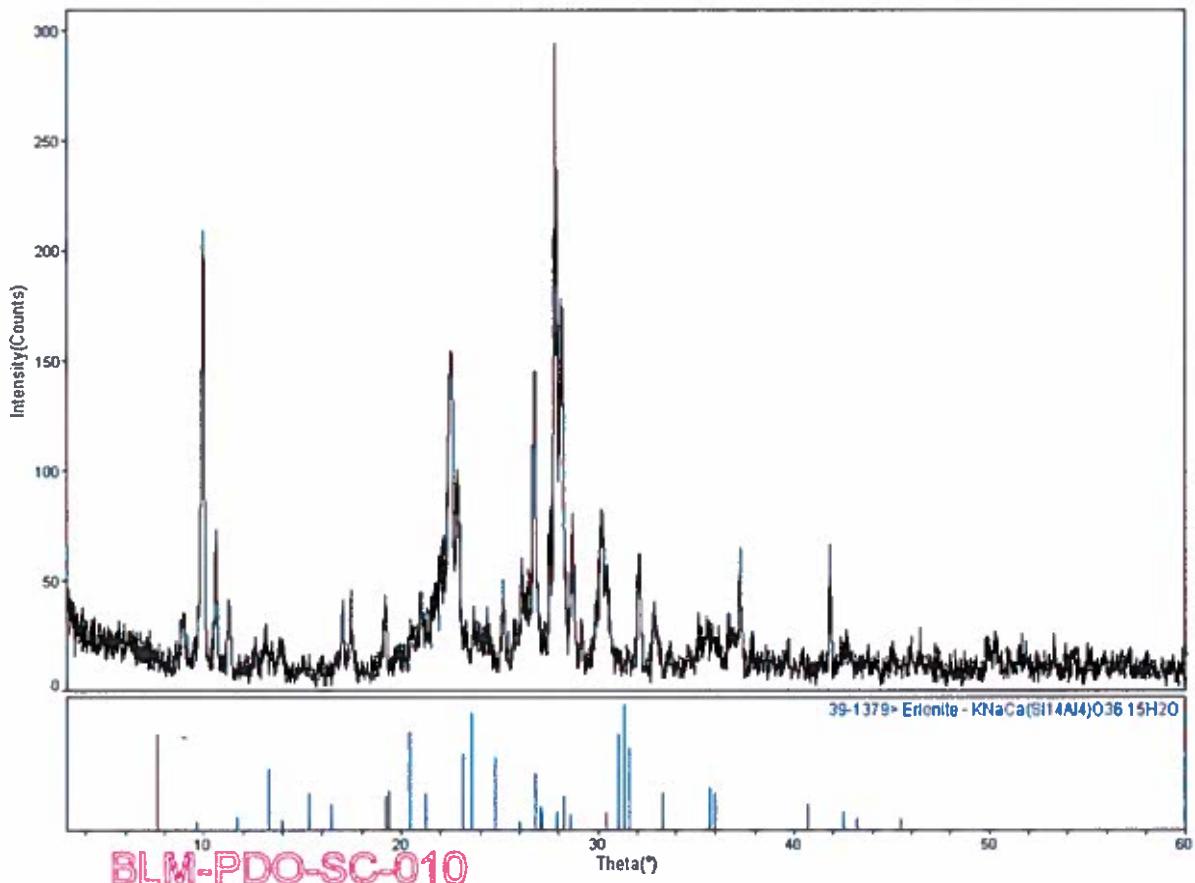
Figure 2. General XRD pattern of material from sample BLM-PDO-SC-010 compared to the PDF # 39-1379 for Erionite. No peaks associated with Erionite were found.

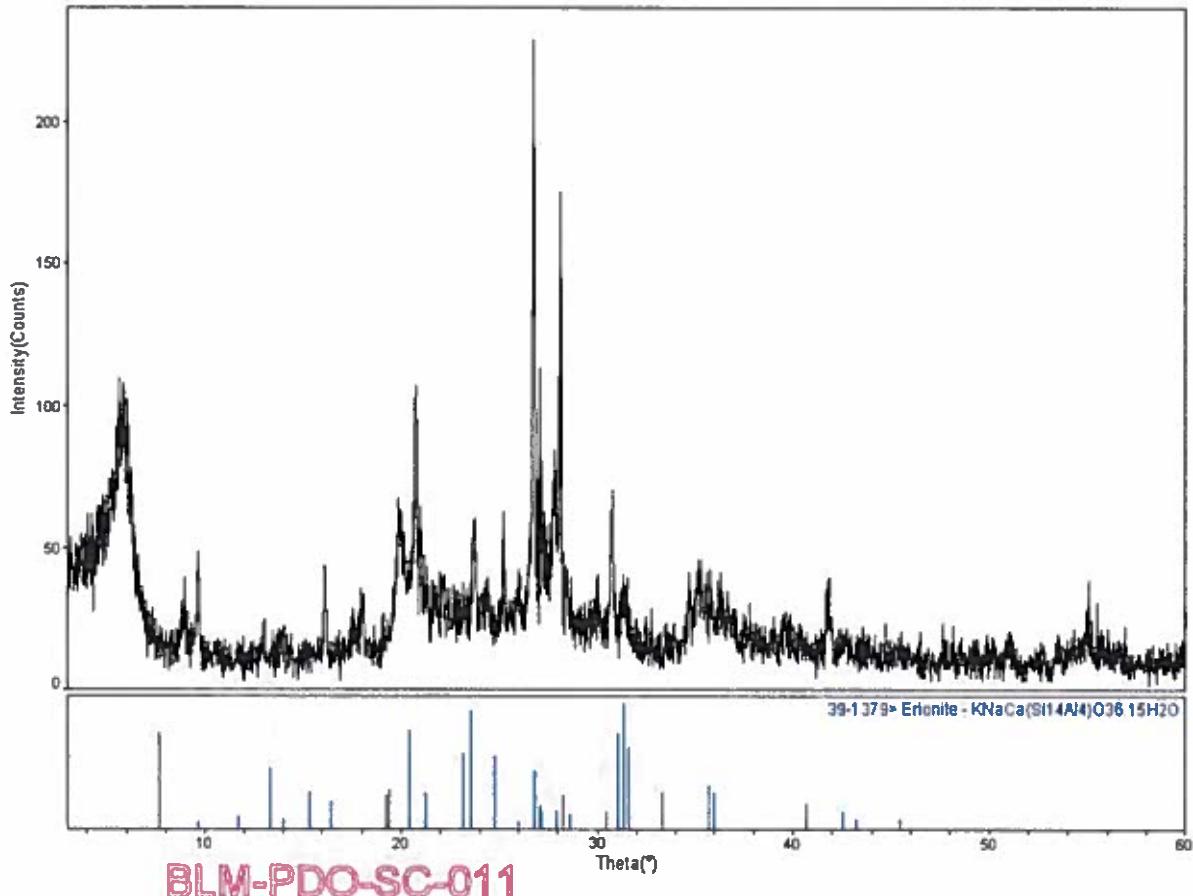
Figure 5. General XRD pattern of material from sample BLM-PDO-SC-011 compared to PDF# 39-1379 for Erionite. No peaks associated with Erionite were found.

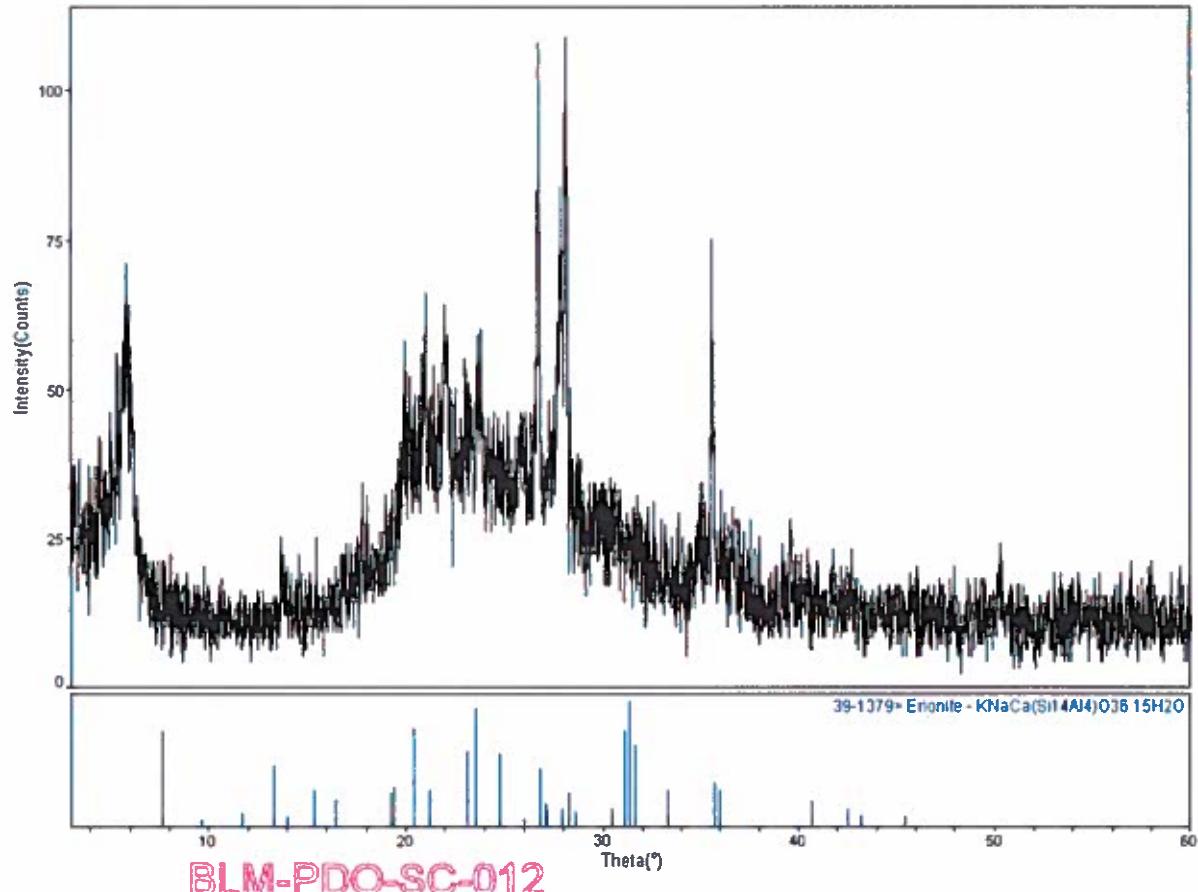
Figure 8. General XRD pattern of material from sample BLM-PDO-SC-012 compared to PDF# 39-1379 for Erionite. No peaks associated with Erionite were found.

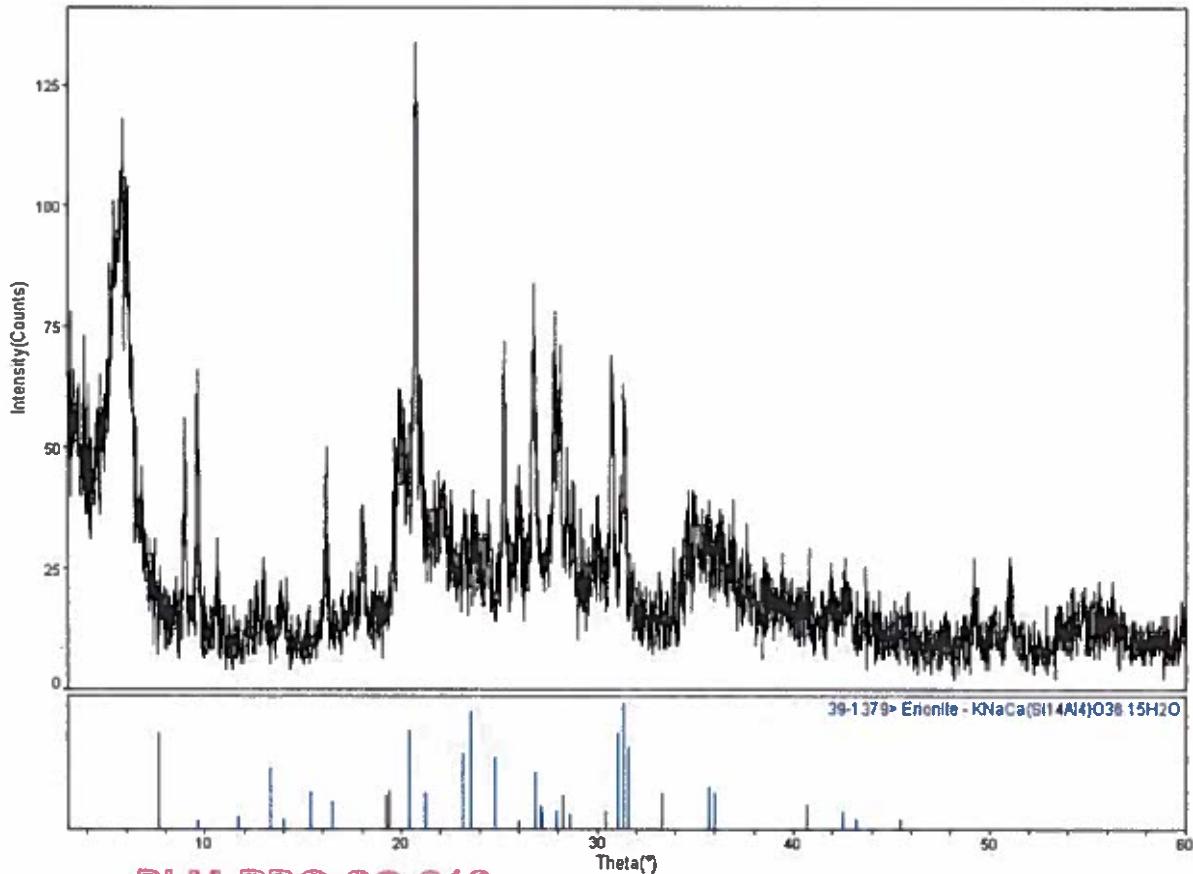
Figure 11. General XRD pattern of material from sample BLM-PDO-SC-016 compared to PDF# 39-1379 for Erionite. No peaks associated with Erionite were found.
