GEOCHEMICAL ASSAY TESTING FOR THE POSSIBLE PRESENCE OF AIRBORNE CARCINOGENS AT THE PROPOSED KIRKLAND HIGH QUALITY POZZOLAN MINE, YAVAPAI COUNTY, ARIZONA

BLM Hassayampa Field Office Locatable Minerals Program, Phoenix, AZ
Dr. S. Cave. Geologist

April 2018 Draft

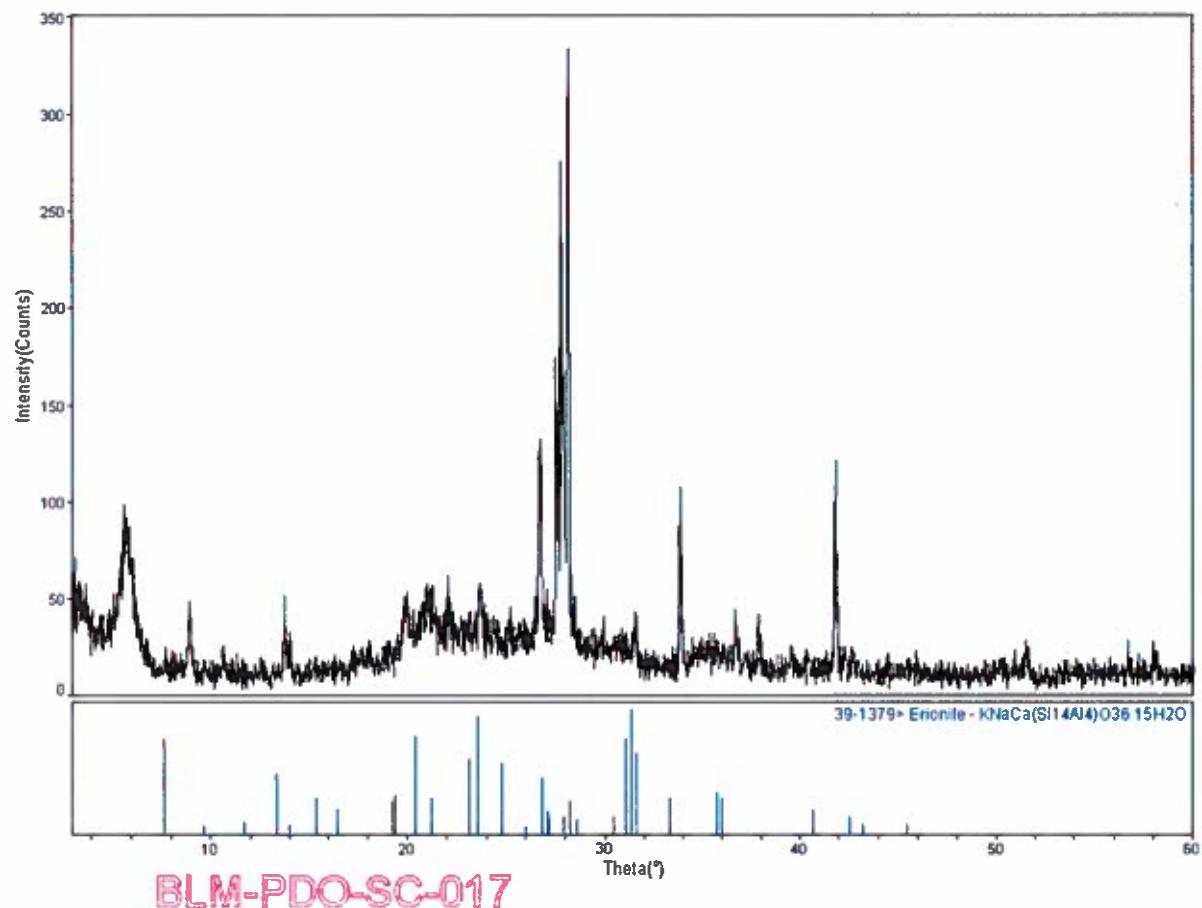
Figure 14. General XRD pattern of material from sample BLM-PDO-SC-017 compared to PDF# 39-1379 for Erionite. No peaks associated with Erionite were found.

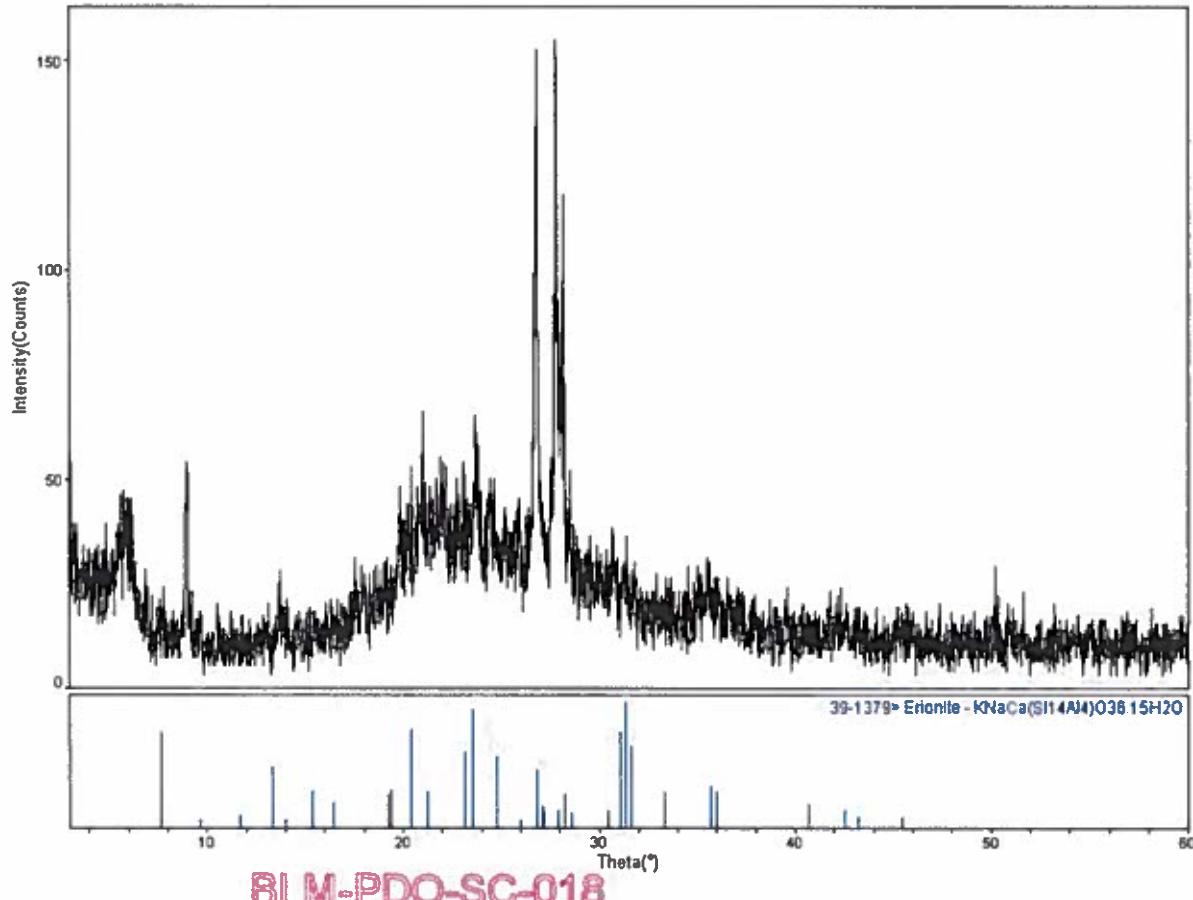
Figure 17. General XRD pattern of material from sample BLM-PDO-SC-018 compared to PDF# 39-1379 for Erionite. No peaks associated with Erionite were found.

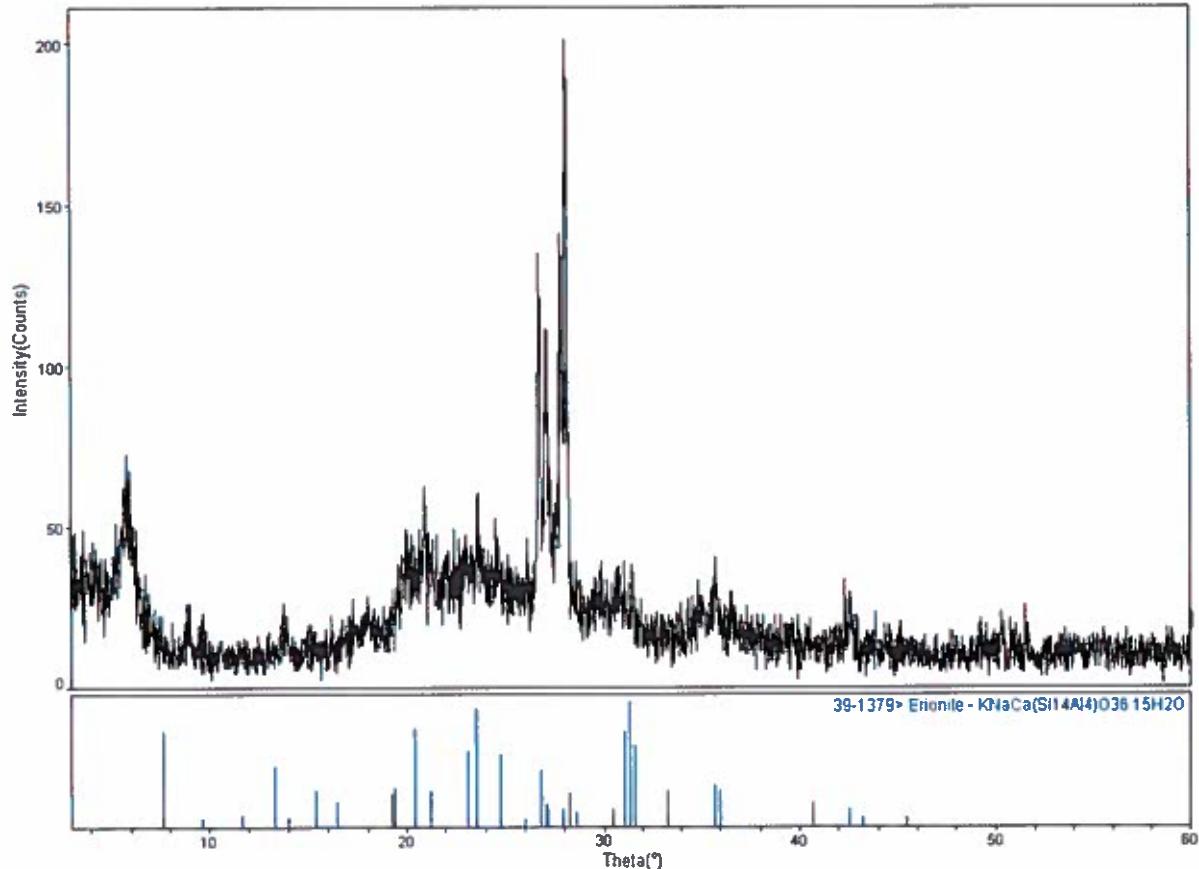
Figure 20. General XRD pattern of material from sample BLM-PDO-SC-021 compared to PDF# 39-1379 for Erionite. No peaks associated with Erionite were found.

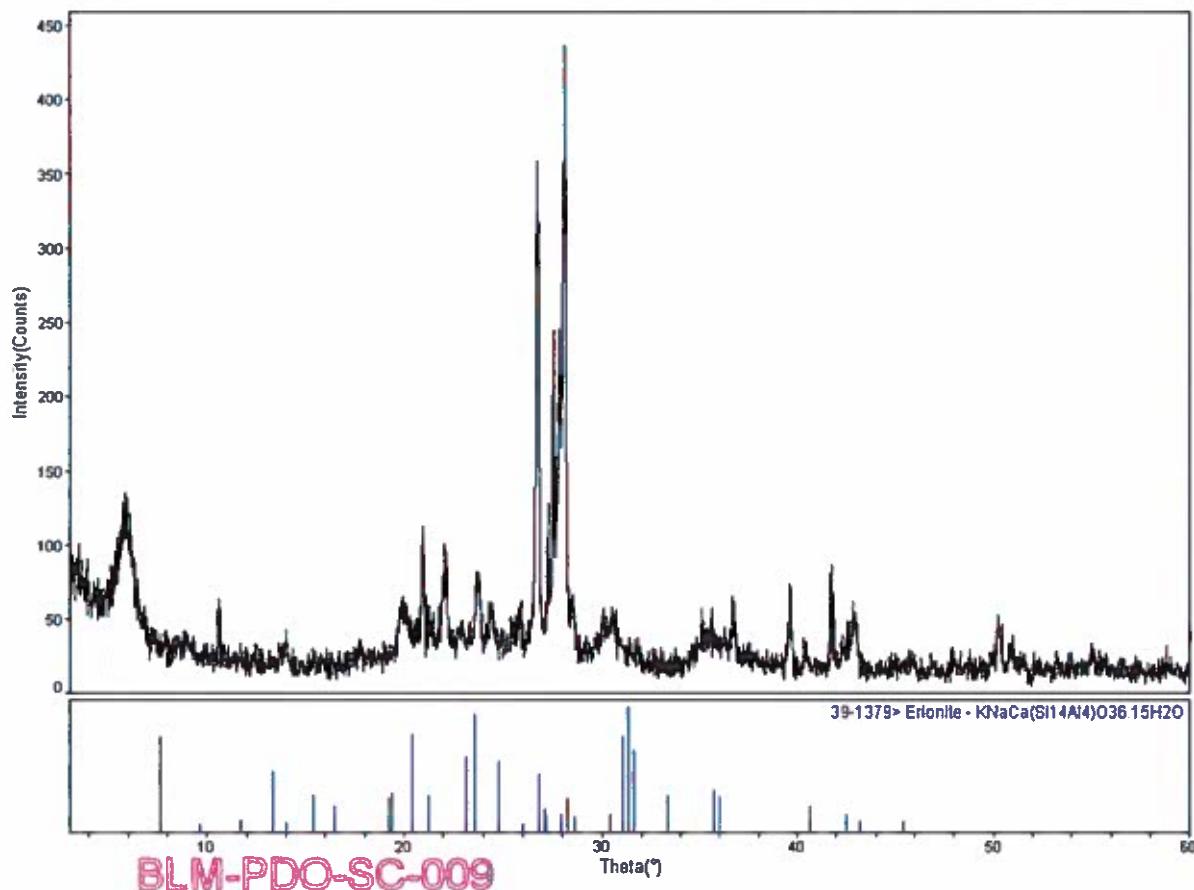
Figure 2. General XRD pattern of material from sample BLM-PDO-SC-009 compared to the PDF # 39-1379 for Erionite. No peaks associated with Erionite were found.

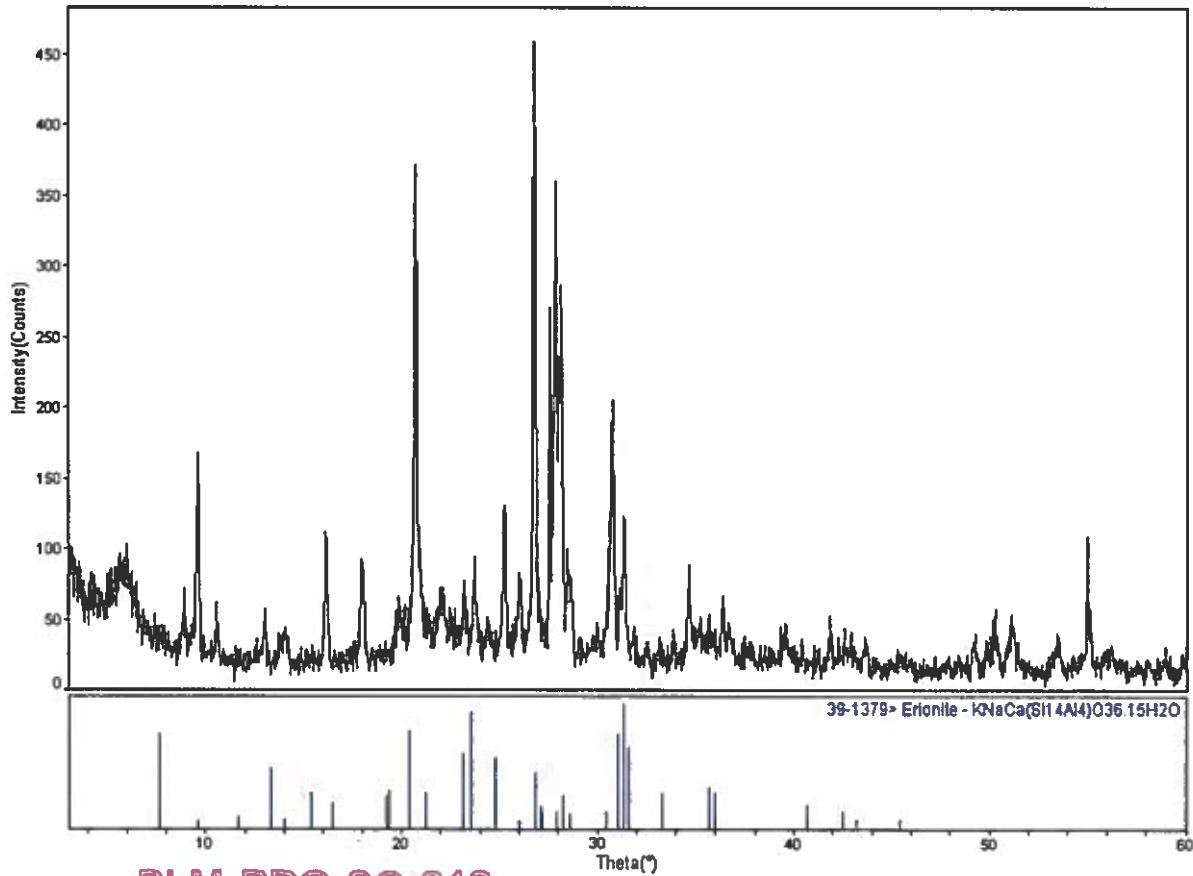
Figure 5. General XRD pattern of material from sample BLM-PDO-SC-013 compared to PDF# 39-1379 for Erionite. No peaks associated with Erionite were found.

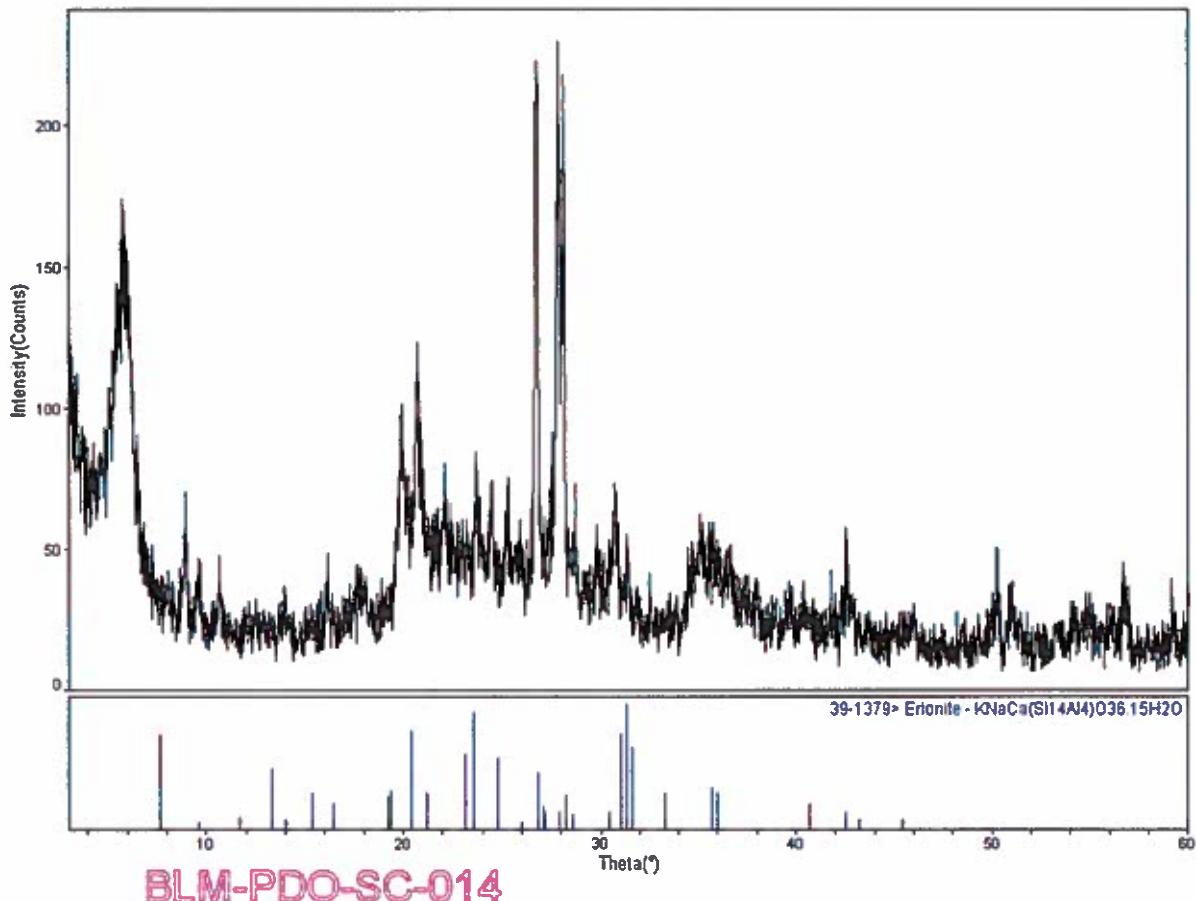
Figure 8. General XRD pattern of material from sample BLM-PDO-SC-014 compared to PDF# 39-1379 for Erionite. No peaks associated with Erionite were found.

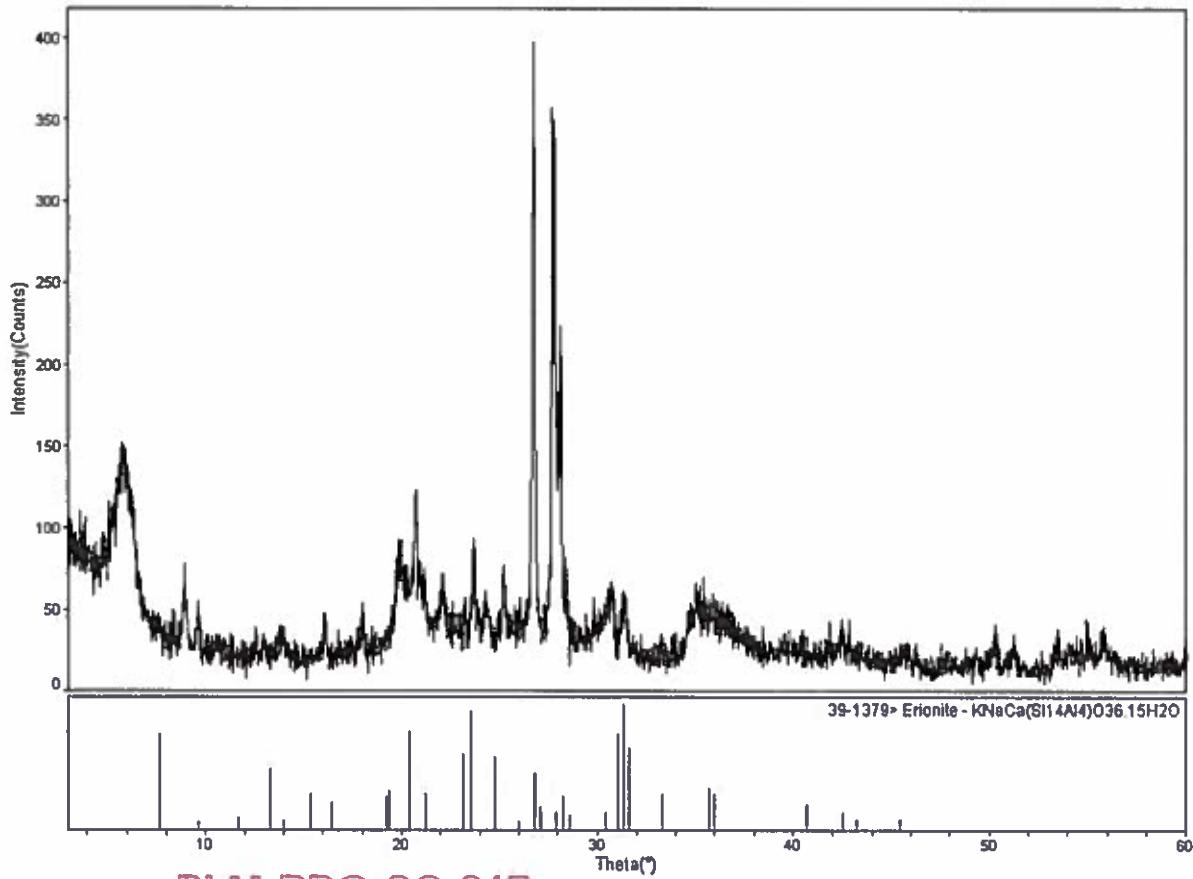
Figure 11. General XRD pattern of material from sample BLM-PDO-SC-015 compared to PDF# 39-1379 for Erionite. No peaks associated with Erionite were found.

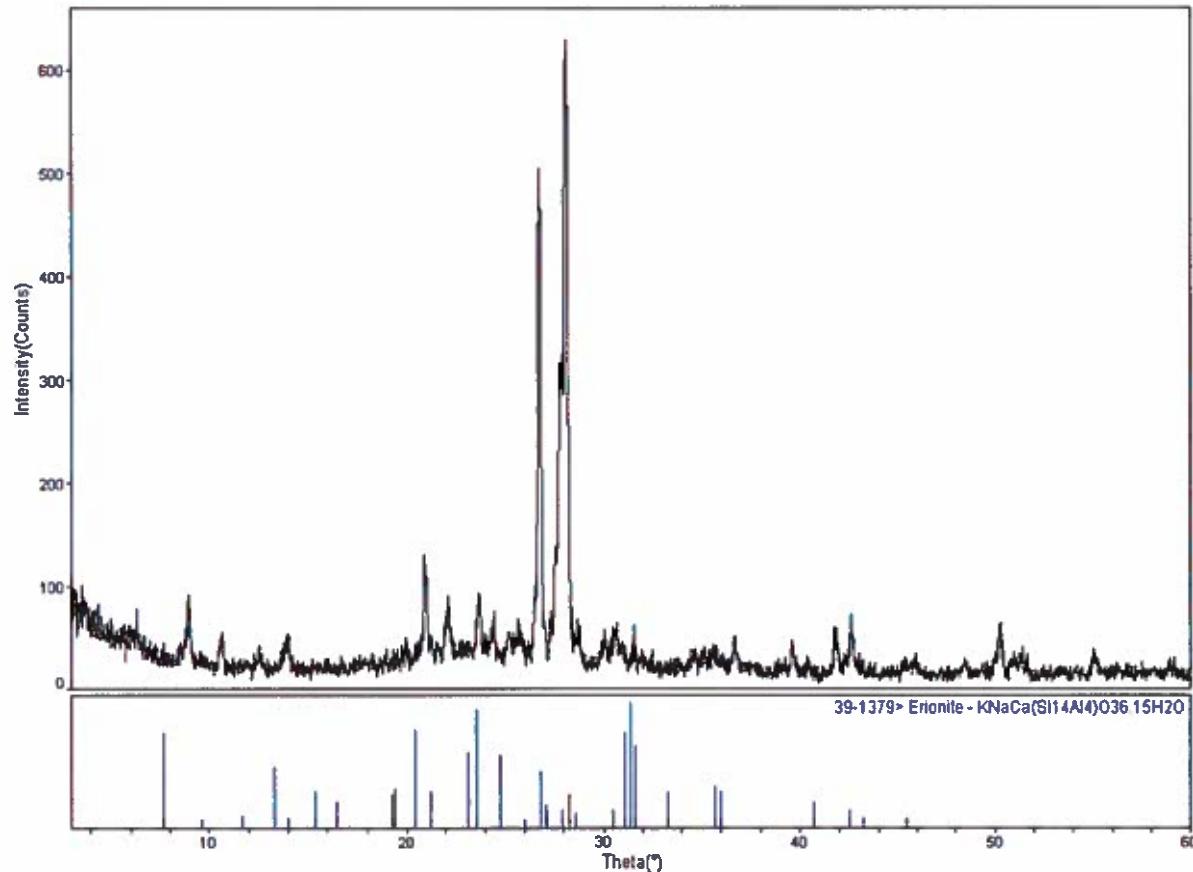
Figure 14. General XRD pattern of material from sample BLM-PDO-SC-019 compared to PDF# 39-1379 for Erionite. No peaks associated with Erionite were found.

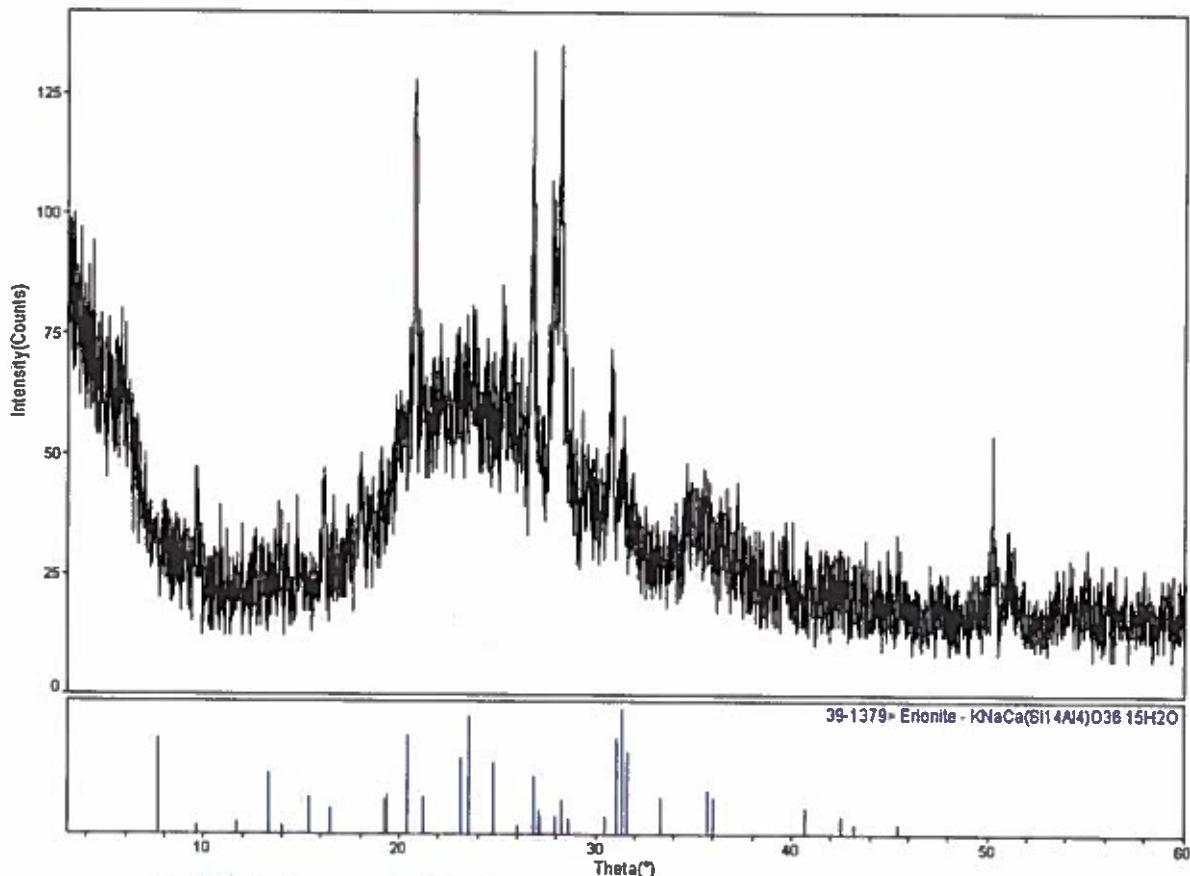
Figure 17. General XRD pattern of material from sample BLM-PDO-SC-020 compared to PDF# 39-1379 for Erionite. No peaks associated with Erionite were found.
